**DEPARTMENT OF TRANSPORTATION**

Contract #: 04-0120F4Cty: SF/ALA Rte: 80 PM: 13.2/13.9File #: 69.28**WELDING INSPECTION REPORT****Resident Engineer:**Pursell, Gary**Address:** 333 Burma Road**City:** Oakland, CA 94607**Report No:** WIR-013015**Date Inspected:** 01-Apr-2010**Project Name:** SAS Superstructure**OSM Arrival Time:** 1900**Prime Contractor:** American Bridge/Fluor Enterprises, a JV**OSM Departure Time:** 700**Contractor:** Zhenhua Port Machinery Company, Ltd (ZPMC), Changxing Island **Location:** Shanghai, China**CWI Name:** See Below**CWI Present:** Yes No**Inspected CWI report:** Yes No N/A**Rod Oven in Use:** Yes No N/A**Electrode to specification:** Yes No N/A**Weld Procedures Followed:** Yes No N/A**Qualified Welders:** Yes No N/A**Verified Joint Fit-up:** Yes No N/A**Approved Drawings:** Yes No N/A**Approved WPS:** Yes No N/A**Delayed / Cancelled:** Yes No N/A**Bridge No:** 34-0006**Component:** OBG**Summary of Items Observed:**

**OBG Bay 13**

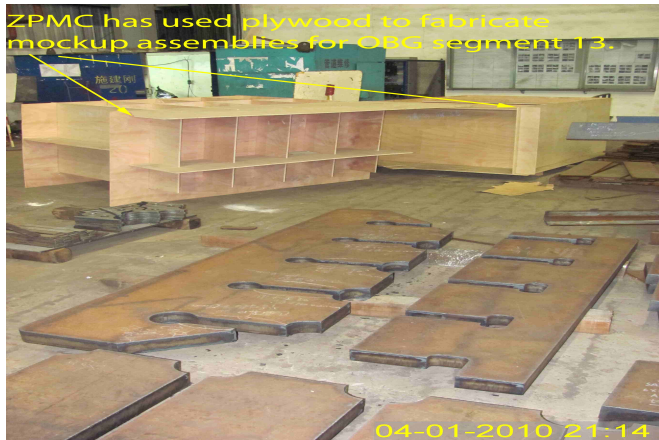
ABF representative Mr. Wang Heng informed this QA Inspector that ZPMC has used plywood to fabricate a mockup assembly of some of the components that will be fabricated as part of OBG segment 13, and this will be constructed using 75 mm thick and 100 mm thick plates. Mr. Wang Heng informed this QA Inspector that ZPMC has also staged some of these plates on the floor of OBG bay 13. See the photograph below for additional information.
